**Flood Control Project Maintenance  
Levee Inspections**

**Fall 2011 Levee Maintenance Deficiency Summary Report**

**Reclamation District No. 2064 River Junction**

**Levee Inspection Report By Mile - Fall 2011**

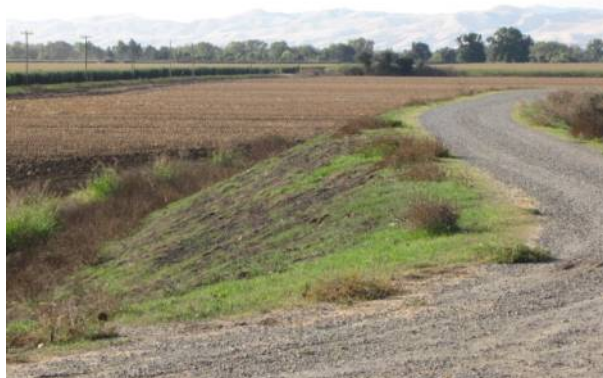
Levee Mile Report Line	1
Start Levee Mile	0.29
End Levee Mile	0.29
Location	Land Side
Category	Earthen Levee
Item	Vegetation

RD 2064 looking downstream from levee mile 0.29. Photo taken 11-02-2011.

Waterway						Bank	Unit Miles	Inspection Start/End		Inspector
Unit No. 01 San Joaquin River						Right	5.70	11/02/2011 11/02/2011		Herman Phillips
LMR No.	Levee Mile		Category	Item	Location *	Rating **	Action/Comment	GPS Latitude/Longitude		Issue No. Photo
	Start	End						Start	End	
1	0.29	0.29	Earthen Levee	Vegetation	LS	A	Remove the wild growth other than native grasses from the levee slopes.	37.707048 ° -121.269115 °	37.707048 ° -121.269115 °	184 Y
2	0.29	0.29	Earthen Levee	Vegetation	WS	A	Remove the wild growth other than native grasses from the levee slopes.	37.707048 ° -121.269115 °	37.707048 ° -121.269115 °	185 Y
3	0.52	0.76	Earthen Levee	Vegetation	LS	M	Remove the wild growth other than native grasses from the levee slopes.	37.704807 ° -121.271321 °	37.701544 ° -121.271822 °	179
4	0.57	2.19	Earthen Levee	Vegetation	WS	M	Remove the wild growth other than native grasses from the levee slopes.	37.704153 ° -121.271375 °	37.688861 ° -121.261755 °	180

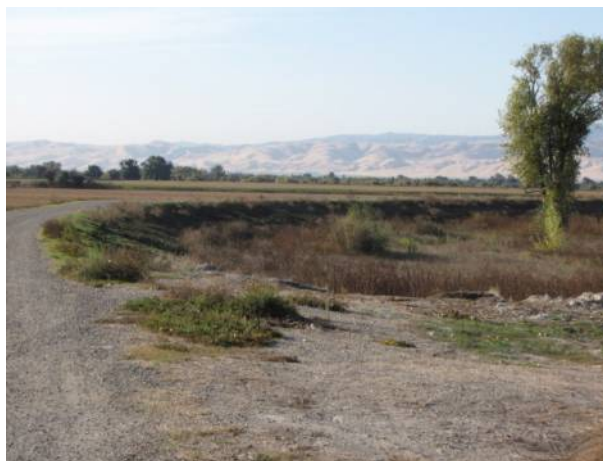
Levee Mile Report Line	2
Start Levee Mile	0.29
End Levee Mile	0.29
Location	Water Side
Category	Earthen Levee
Item	Vegetation

RD 2064 waterside looking downstream from levee mile 0.29 unit 1. Photo taken 11-02-2011.

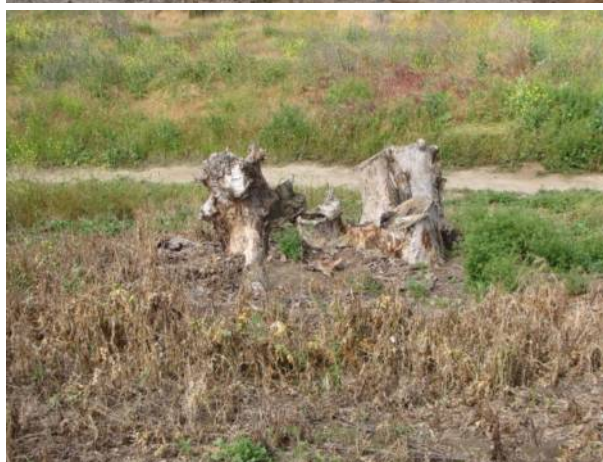
Levee Mile Report Line	6
Start Levee Mile	3.53
End Levee Mile	3.53
Location	Water Side
Category	Earthen Levee
Item	Trim / Thin Trees

View of tree stumps.

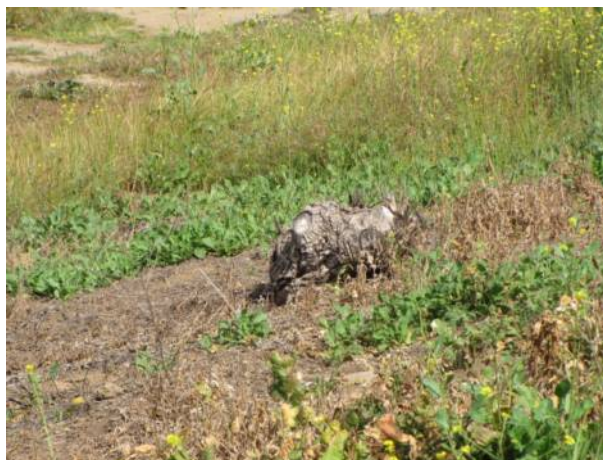
Levee Mile Report Line	7
Start Levee Mile	3.55
End Levee Mile	3.55
Location	Land Side
Category	Earthen Levee
Item	Trim / Thin Trees

View of a tree stump.

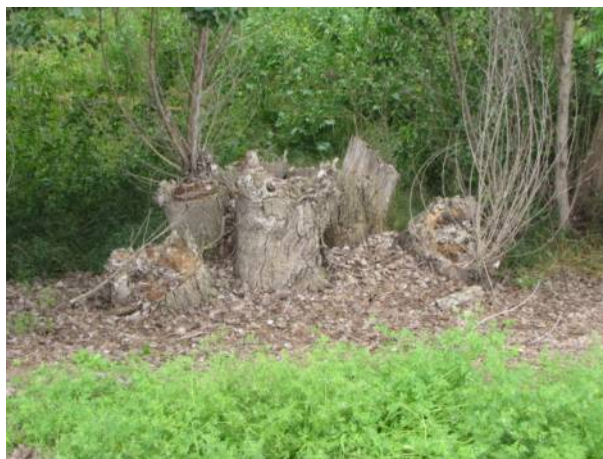
Levee Mile Report Line	9
Start Levee Mile	3.66
End Levee Mile	3.66
Location	Land Side
Category	Earthen Levee
Item	Trim / Thin Trees

View of tree stumps.

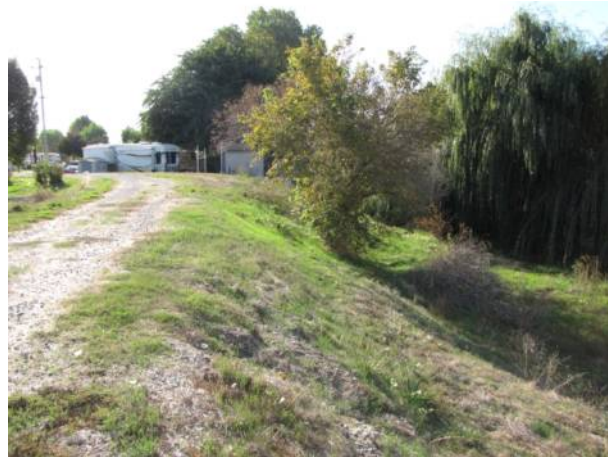
Levee Mile Report Line	1
Start Levee Mile	0.00
End Levee Mile	0.00
Location	Water Side
Category	Earthen Levee
Item	Vegetation
RD 2064 Unit 2 standing at levee mile 0.00 waterward looking downstream. Photo taken 11-02-2011	
phillips_f_20111207_107.jpg

Waterway						Bank	Unit Miles	Inspection Start/End		Inspector
Unit No. 02 Stanislaus River						Right	6.20	11/02/2011 11/02/2011		Herman Phillips
LMR No.	Levee Mile		Category	Item	Location	Rating	Action/Comment	GPS Latitude/Longitude		Issue No. Photo
	Start	End						Start	End	
1	0.00	0.00	Earthen Levee	Vegetation	WS	A	Remove the wild growth other than native grasses from the levee slopes.	37.667180 ° -121.220500 °	37.667180 ° -121.220500 °	236 Y
2	0.00	0.00	Earthen Levee	Vegetation	LS	A	Remove the wild growth other than native grasses from the levee slopes.	37.667180 ° -121.241009 °	37.667180 ° -121.241009 °	238 Y
3	0.17	0.56	Earthen Levee	Vegetation	LS	M	Remove the wild growth other than native grasses from the levee slopes.	37.666400 ° -121.238267 °	37.663462 ° -121.232856 °	229
4	0.17	0.71	Earthen Levee	Vegetation	WS	M	Remove the wild growth other than native grasses from the levee slopes.	37.666399 ° -121.238267 °	37.664036 ° -121.230627 °	230

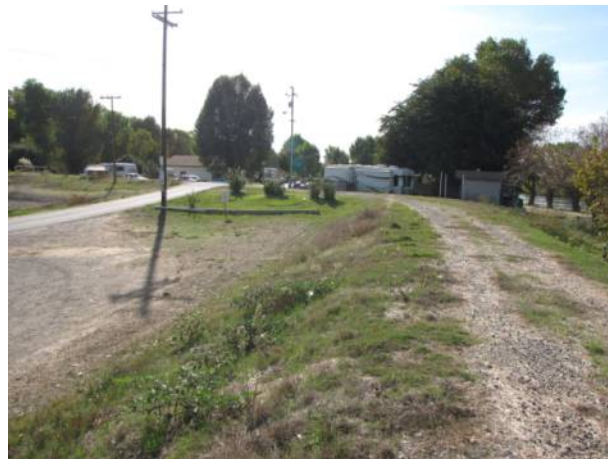
Levee Mile Report Line	2
Start Levee Mile	0.00
End Levee Mile	0.00
Location	Land Side
Category	Earthen Levee
Item	Vegetation
RD 2064 Unit 2 looking downstream from levee mile 0.00. Photo taken 11-02-2011.	
phillips_f_20111207_108.jpg

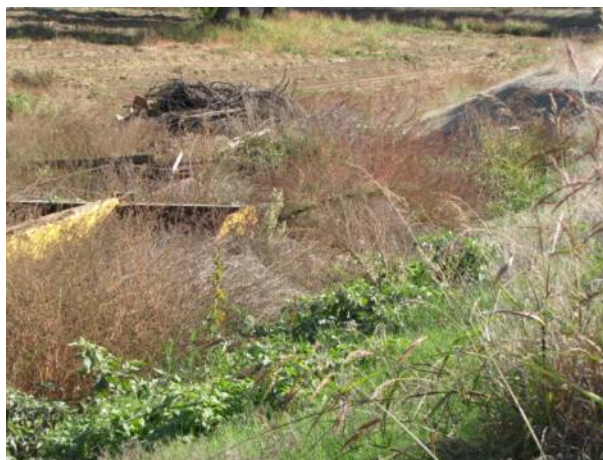
Levee Mile Report Line	5
Start Levee Mile	0.34
End Levee Mile	0.54
Location	Land Side
Category	Earthen Levee
Item	Encroachments
Unauthorized encroachment to levee mile 0.54. Photo taken 11-02-2011.	
phillips_f_20111207_110.jpg

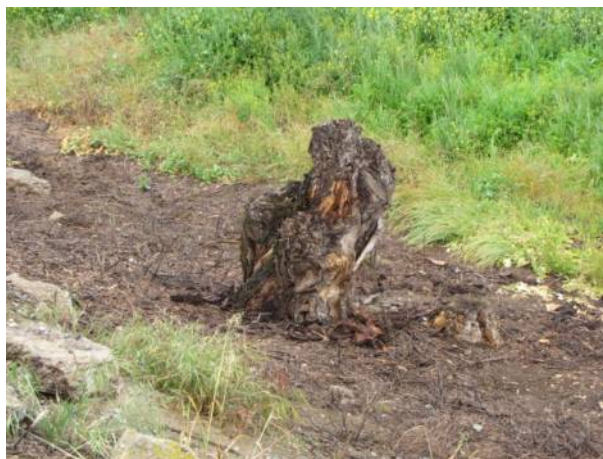
Levee Mile Report Line	6
Start Levee Mile	0.99
End Levee Mile	0.99
Location	Water Side
Category	Earthen Levee
Item	Trim / Thin Trees
levee mile 0.99	
phillips_f_20111010_224.jpg

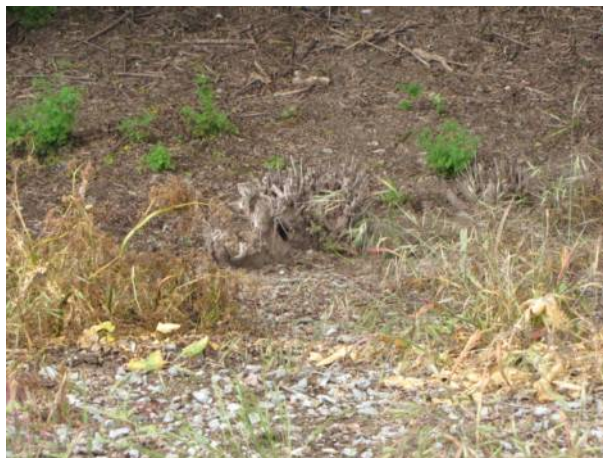
Levee Mile Report Line	10
Start Levee Mile	1.76
End Levee Mile	1.76
Location	Land Side
Category	Earthen Levee
Item	Trim / Thin Trees
View of a tree stump.	
phillips_f_20111010_225.jpg

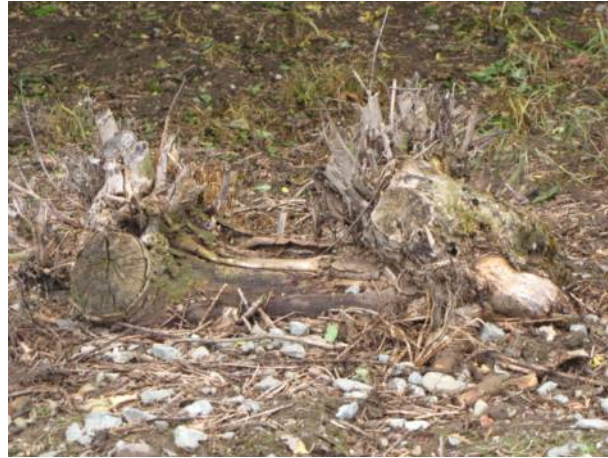
Levee Mile Report Line	11
Start Levee Mile	1.78
End Levee Mile	1.78
Location	Land Side
Category	Earthen Levee
Item	Trim / Thin Trees

View of a tree stump.

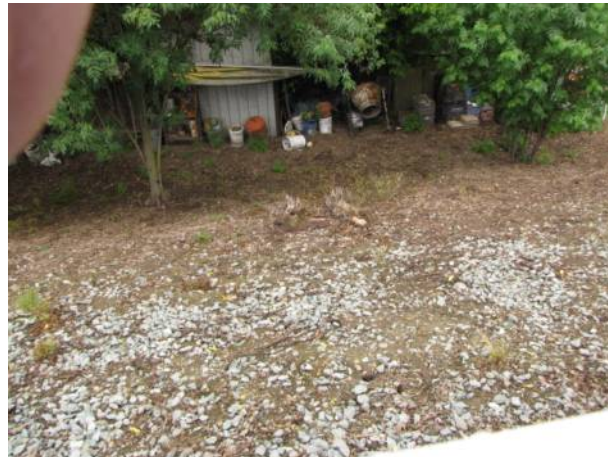
Levee Mile Report Line	12
Start Levee Mile	1.79
End Levee Mile	1.81
Location	Land Side
Category	Earthen Levee
Item	Trim / Thin Trees

View of a tree stump.

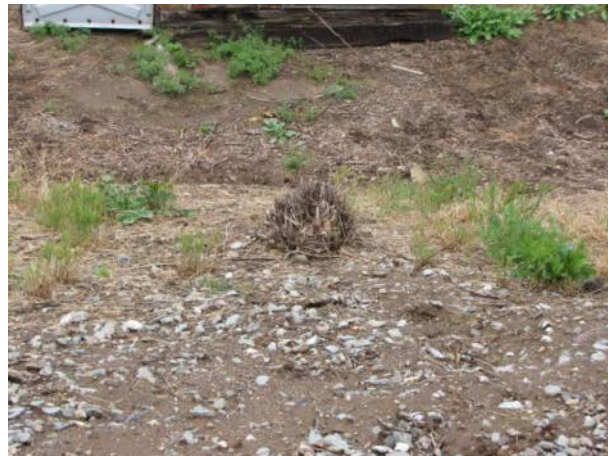
Levee Mile Report Line	14
Start Levee Mile	1.86
End Levee Mile	1.86
Location	Land Side
Category	Earthen Levee
Item	Trim / Thin Trees

View of a tree stump.
